## Observations from the EEFIT-TDMRC Mission to Sulawesi, Indonesia to Investigate the 28th September 2018 Central Sulawesi Earthquake

Lagesse, Richard; Rossetto, Tiziana; Raby, Alison; Brennan, Andrew; Robertson, David; Adhikari, Rohit Kumar

*Published in:*  
SECED 2019 Proceedings

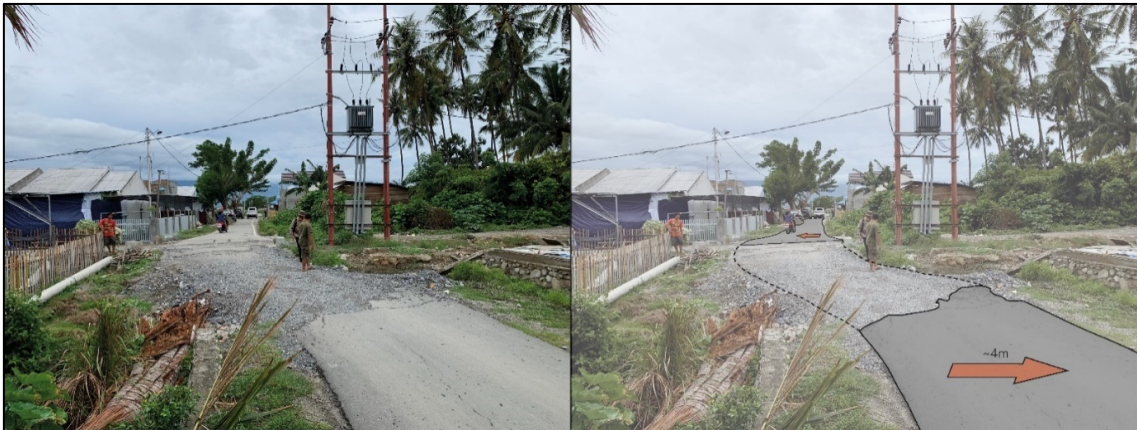
Numerous expressions of the fault surface rupture were identified throughout the area, typically by the offset of linear features such as roads (Figure 2), but also dramatic continuous surface ruptures through agricultural land. Left-lateral strike-slip displacement was measured by the Team to be a maximum of 5m at Pewunu (Figure 3), and typically between 3-4m. It is possible that, as the Pewunu area is in close proximity to the valley sides and steep terrain, the soil is thinner and thus the greater displacements in the bedrock are more closely represented at the surface.

Figure 2. Offset road due to strike-slip fault displacement.

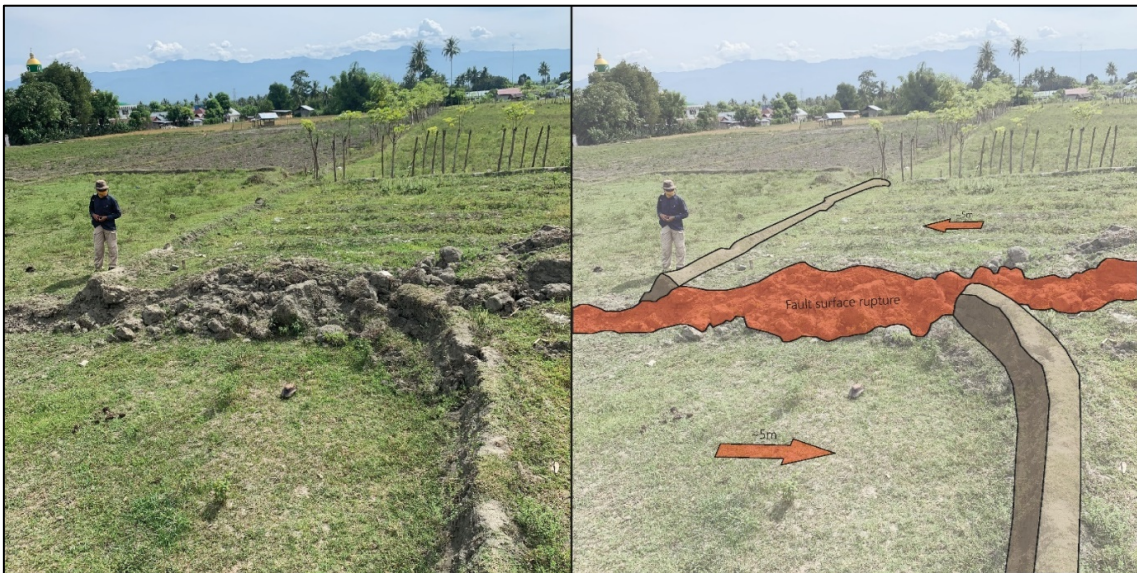
Figure 3. Displacement of approximately 5m along fault surface rupture shown due to offset rice paddy terraces.

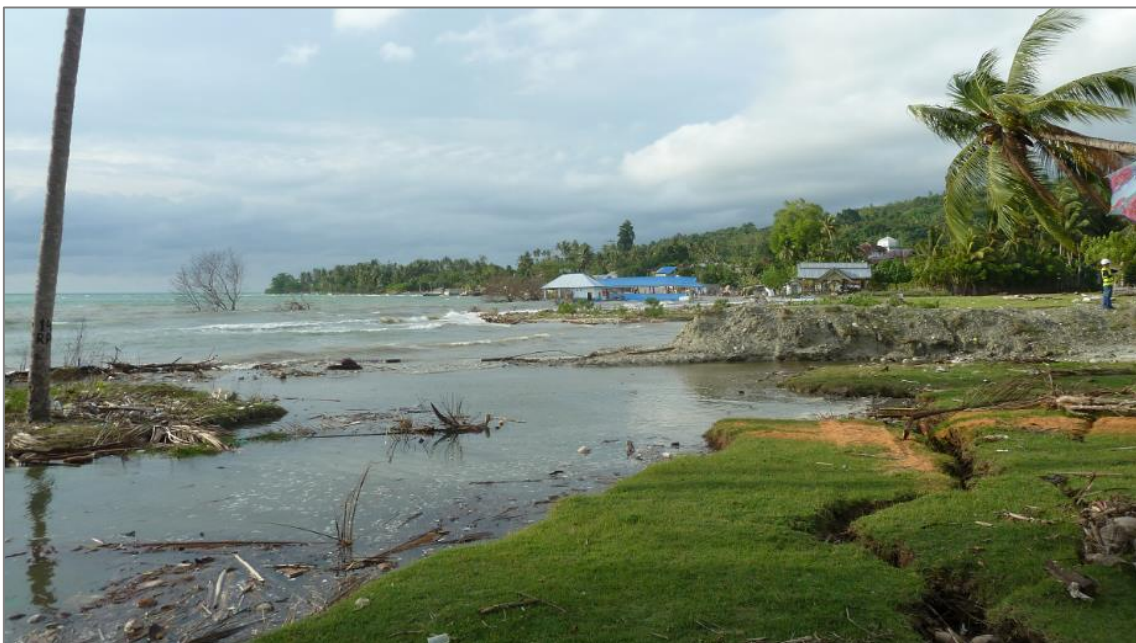
The team identified areas on both sides of Palu Bay affected by seafront loss due to liquefaction. The EEFIT-TDMRC observed this at Loli Tasiburi on the Western shore and at Lero on the Eastern coast. Locals at Loli Tasiburi reported that large areas of coastline had broken off and fallen into the sea, with one indicating Palu, visible in the distance around a headland, which he reported had previously been obscured by the land. An eyewitness described the soil “bubbling”, and two large upwards spurts of water on the beach. The soil type and inevitable high groundwater level suggest liquefaction was a clear possibility, and the eyewitness reports are consistent with soil liquefying. The team concluded that liquefaction had therefore occurred in the coastal soil, and either the resultant large settlements were sufficient to submerge the coastal land or (more likely) lateral spreading has taken the shoreline into the bay.

*Figure 6. Area of land lost to coastal slumping due to liquefaction at Lero.*

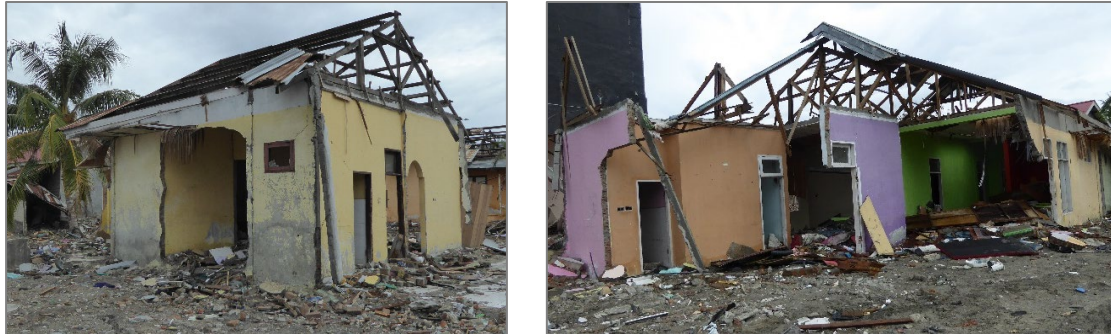
The most common non-engineered construction observed in Palu is confined masonry (CM). Typical damage sustained by CM houses along the coast line in Palu bay area is shown in Figure 9. The main damage pattern is the out of plane failure of walls directly hit by the tsunami waves. In the case of earthquake ground shaking the weak materials used for both the masonry and confining elements resulted in out-of-plane failure of the masonry and cracking and failure of tie-columns.

*Figure 9. Heavily damaged CM houses in Palu bay area along the Jl. Rajamoili road, about 100m from coastline. The walls of this house were directly hit by the tsunami inundation.*

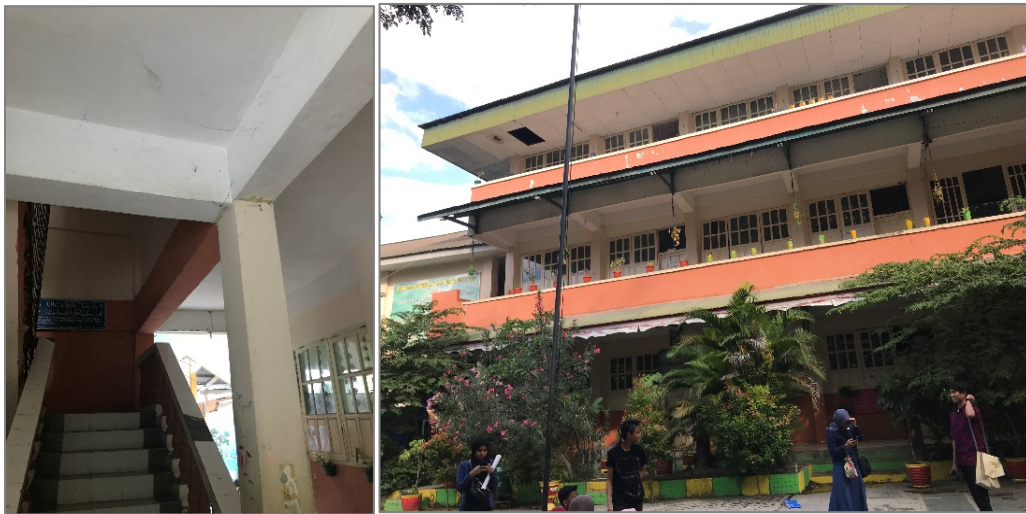
Some reinforced Concrete (RC) school buildings were also observed. These were 2 to 4 storey high, RC frames with brick masonry infill. These school buildings had had some level of seismic design and good material quality. Generally, reinforced concrete school buildings performed well during the earthquake ground shaking. For example, MTS Alkhairaat Pusa Palu School contained 9 two-storey RC school buildings, all of which suffered no damage. Only one 3-storey RC building at this school complex had suffered light damage to its infill walls (Figure 11). In fact, damage to masonry infill walls was the predominant damage observed in RC frame school buildings that were subjected to earthquake ground shaking only, and an example is shown in Figure 12.

Figure 11. MTS Alkhairaat Pusa Palu School. Left – 3-torey RC frame building that sustained minor damage to infill panels. Right – Typical sizes of beams and columns in RC frame schools.

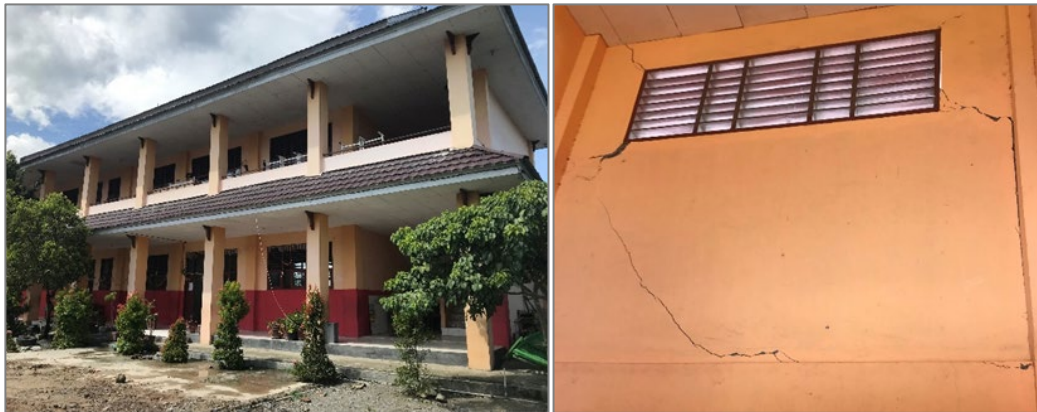
Figure 12. Damage to infill walls in a 2-storey RC school building in SD Negeri Pengawu School in Palu (Building A in Fig. 7.24).
